Part I: A Guide for Management
Part II: Description of the Cultural Resources
and Recommendations

EAST BASE

Historic Monument • Stonington Island/Antarctic Peninsula

April 1993

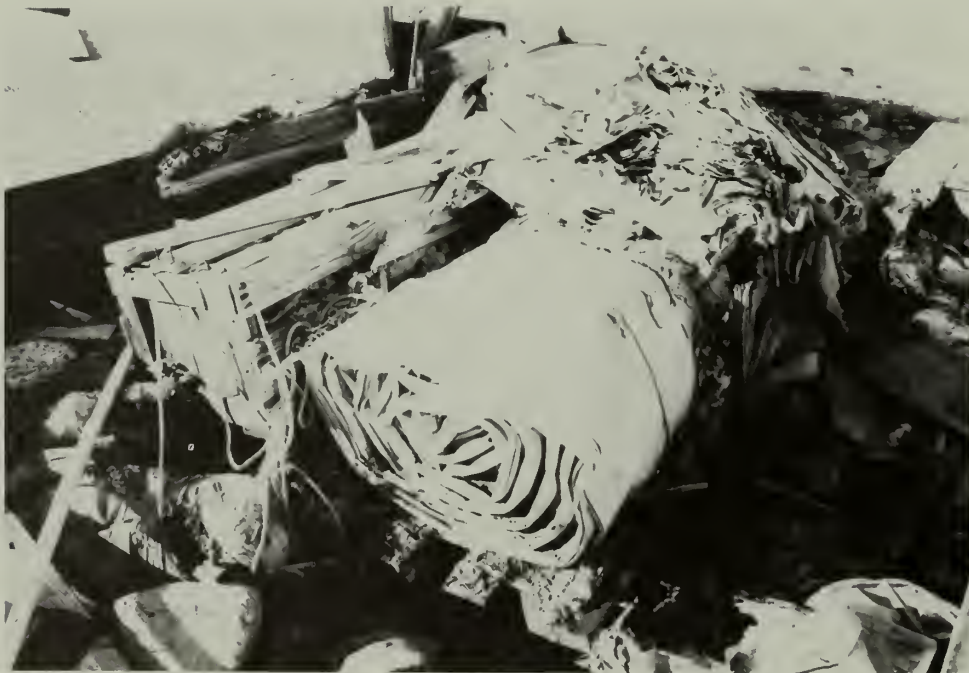
Dump E consists of two piles of trash surrounded by a surface scatter trending from the northwest corner of the machine shop to a point about 22 feet north of the northwest corner of the science building. The westernmost pile shows evidence of burning and appears to have contained true trash, i.e., material that was no longer useful. Slag and melted glass were relatively abundant.

The eastern pile resembled the contents of dump C in that a considerable amount of usable goods had been disposed. These include a large amount of medical materials, such as antigangrene toxin, triangular hospital slings, hypodermic needles, and cast wrappings. A large number of bottles of pills and capsules were also observed. Not all of the dump material was medical in nature, however. Some bottles contained chemicals involved in the processing of film. These are all items that would have been used in the machine shop and science building. Personal items included a fur-backed glove and a metal plaque with the name of C.W. Sharbonneau, the carpenter with USAS. This sort of plaque had been used to label each man's bunk and was, without a doubt, disposed of by RARE when they occupied the base. These personal items indicate that some items from the main building were also disposed of in this location.

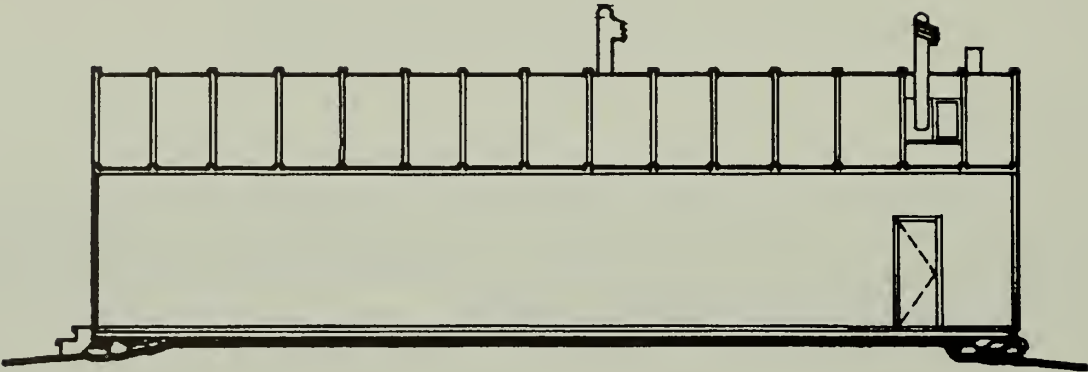
A small hut about 200 feet from East Base, associated with British activities on the island.

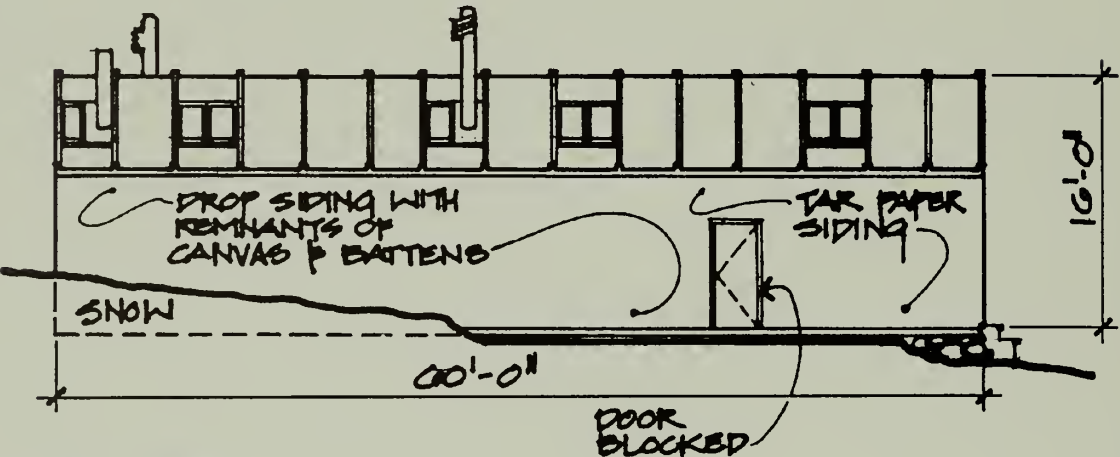
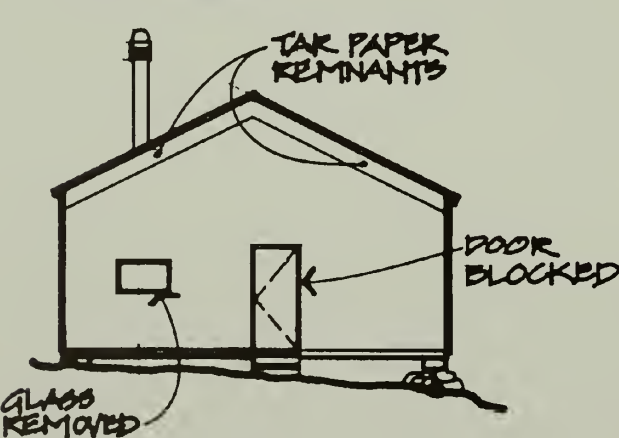
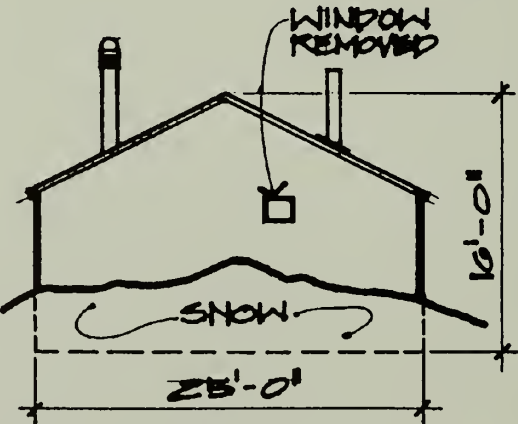
MAIN BUILDING (BUNKHOUSE)

The building's interior is a mess of seal debris and ice. The rear door is broken open, as is the roof entrance. Windows are also broken. The ice at the rear of the building is approximately 6 feet thick. Its extent is unknown because of the overlay of seal debris. Also, mattresses and other objects can be identified under the mess.

The building has not been inspected by an architect or a structural engineer, and work on the building should be limited to maintenance until these professionals can visit the site and make recommendations. The foundation may be failing, and the roof structure may be unsound.

1. Have an architect inspect the structure and prepare a historic structure report to guide any long-term work. The report should include a discussion on removal of ice and seal debris while ensuring the preservation of the building's structural integrity.
2. Immediately cover open windows and repair and close the rear and roof entranceways in order to make the building weather tight. Replacement of any exterior covering, either canvas or tar paper, and any major structural repair should await the recommendations of an architect.
3. Prepare Historic American Building Survey documentation of the structure.
4. Provide for the interpretation of the building either by pamphlet or interpretive signage.
5. Close the building to visitors and install warning signs about the interior condition.
6. Assess the possible use of the clean front room for artifact storage.

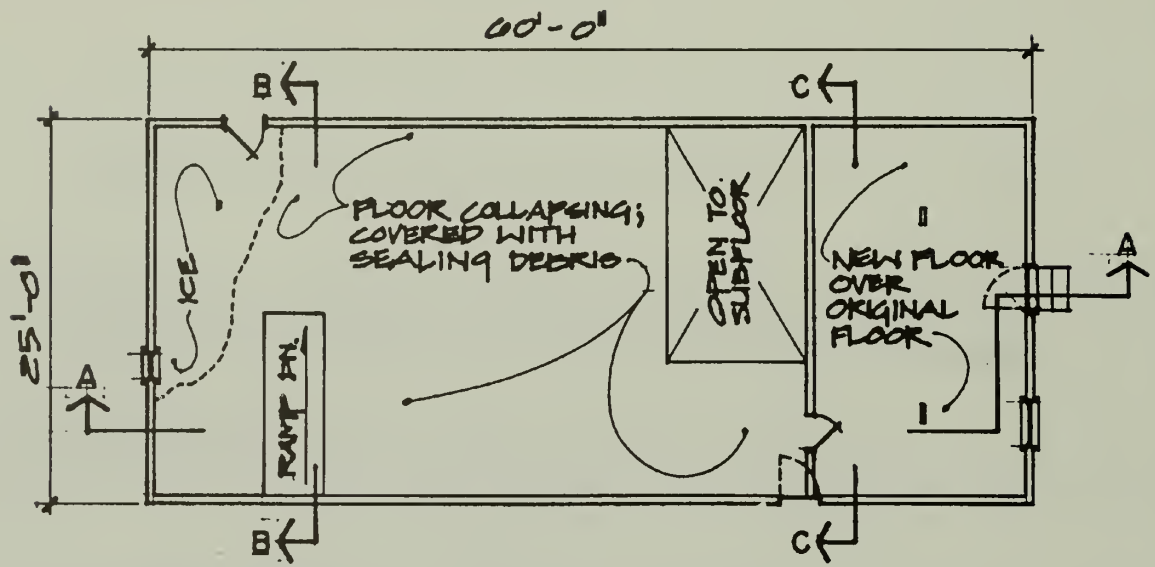
The main building, built in March 1940, was used as bunkhouse, mess, kitchen, and office by both the USAS and RARE. In the 1950s to 1960s, the British Base E crew used the building for seal storage.

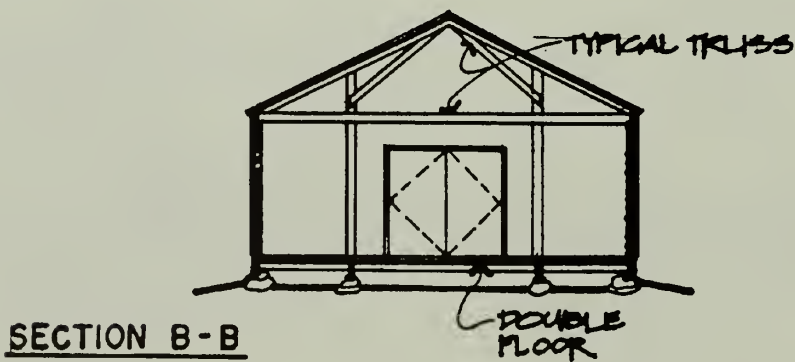
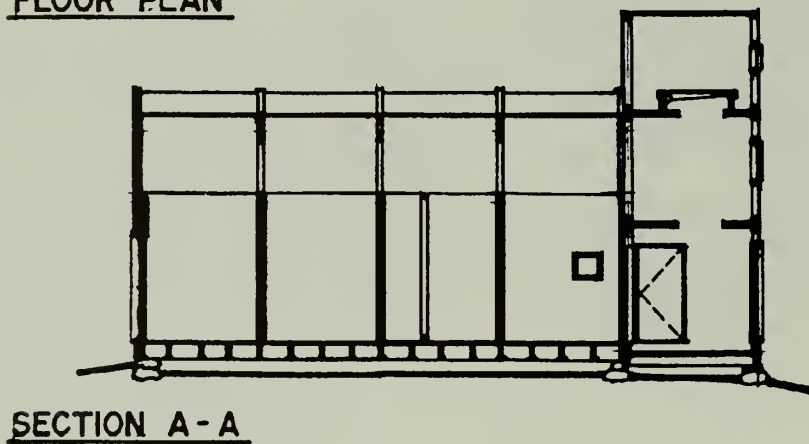
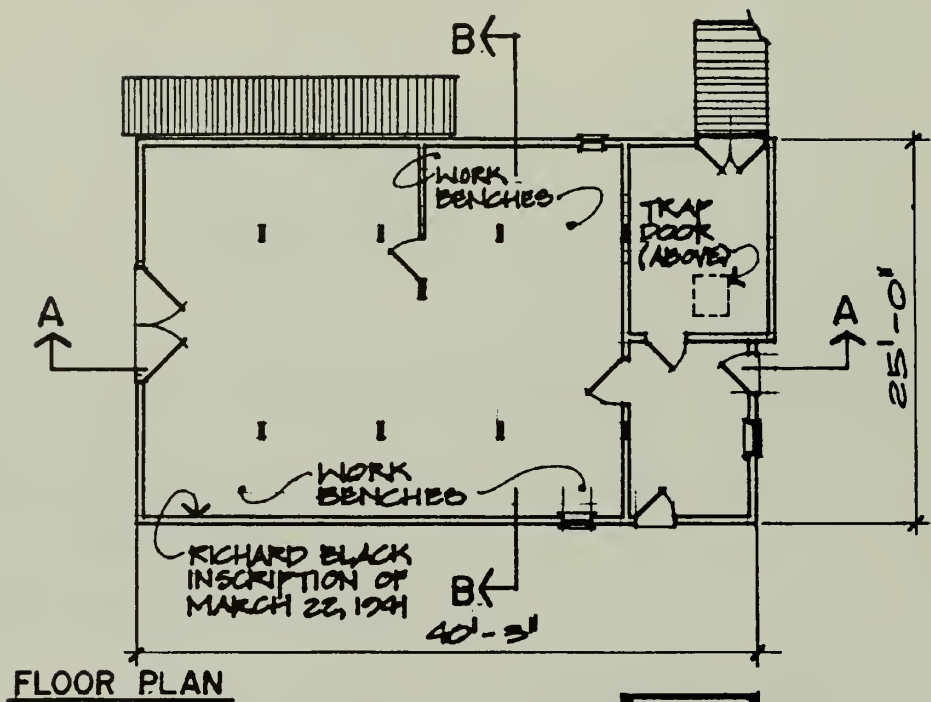
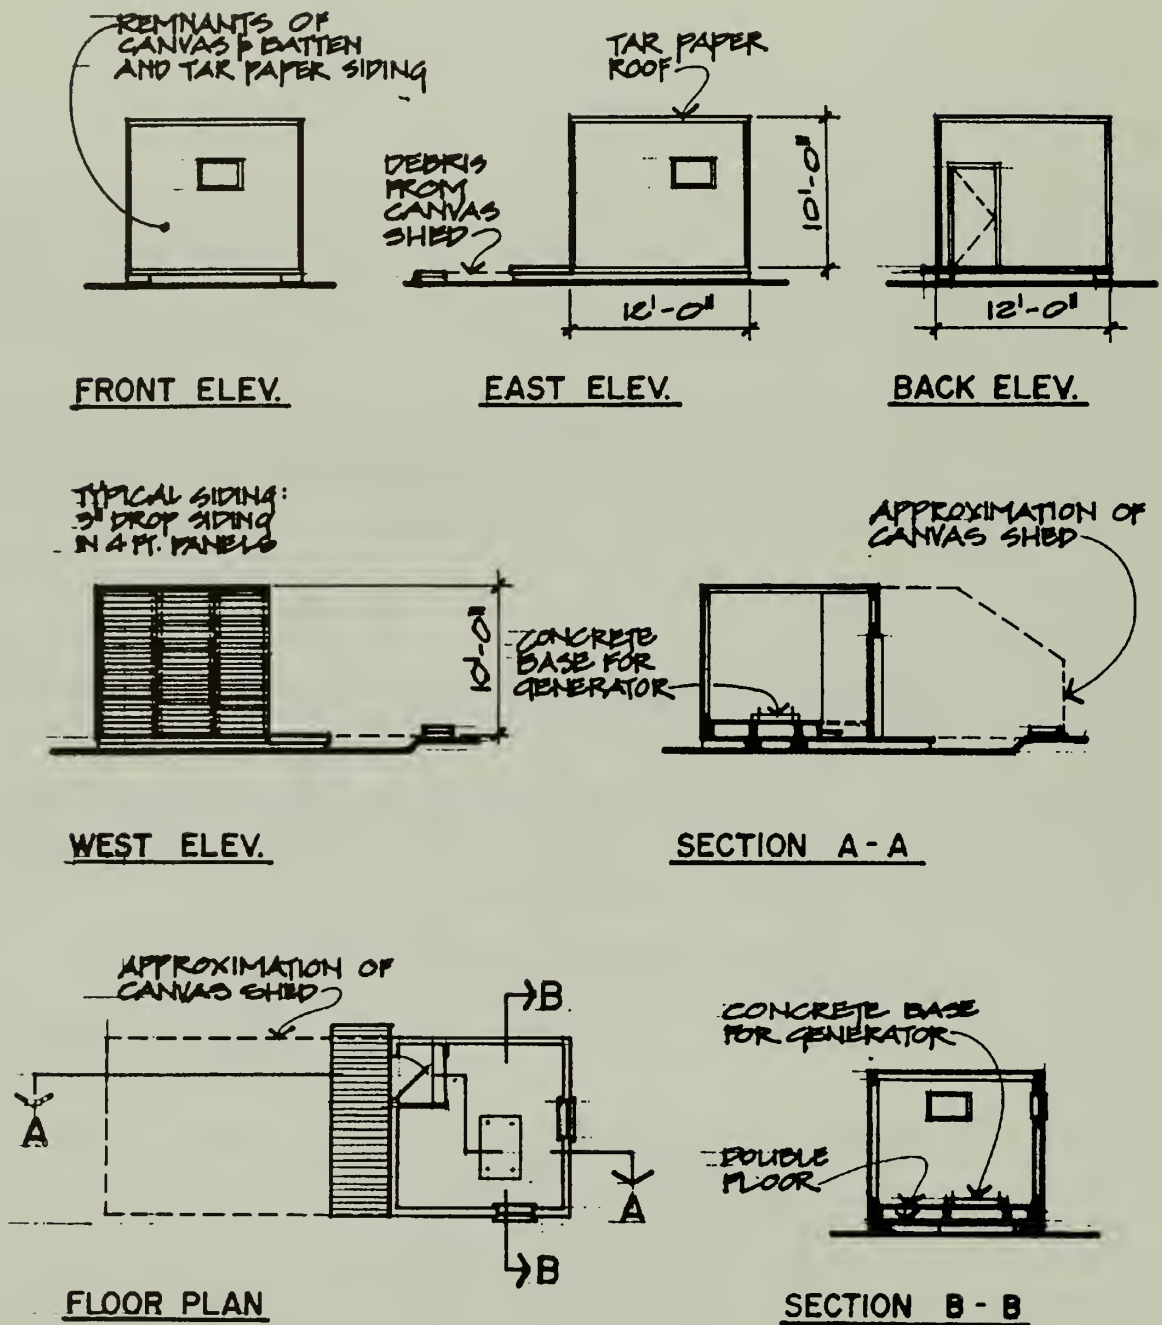
SCIENCE BUILDING

The science building was constructed in April 1940 to house the scientific instruments of both the USAS and RARE. A tower, divided into three levels, was attached to the south end for meteorological work. An addition to the south end of the building added a more protected entrance and space for a seismograph. The interior was remodeled by the British in the 1950s for sled storage. The structure is vacant and unused.

The building has not been inspected by an architect or structural engineer, and work on the building should be limited to maintenance until one can visit the site and make recommendations. Some doors and windows are open. The foundation may be failing, and the roof structure may be unsound.

1. Have an architect inspect the structure and prepare a historic structure report to guide any long-term work.
2. Immediately cover open windows, place the front door back on its hinges, and repair the rear door so it can close in order to make the building weather tight. Replacement of any exterior covering, either canvas or tar paper, and any major structural repair should await the recommendations of an architect.
3. Prepare Historic American Building Survey documentation of the structure.
4. Provide for the interpretation of the building either by pamphlet or interpretive signage.
5. Provide for the protection of the Richard B. Black message of March 22, 1941.

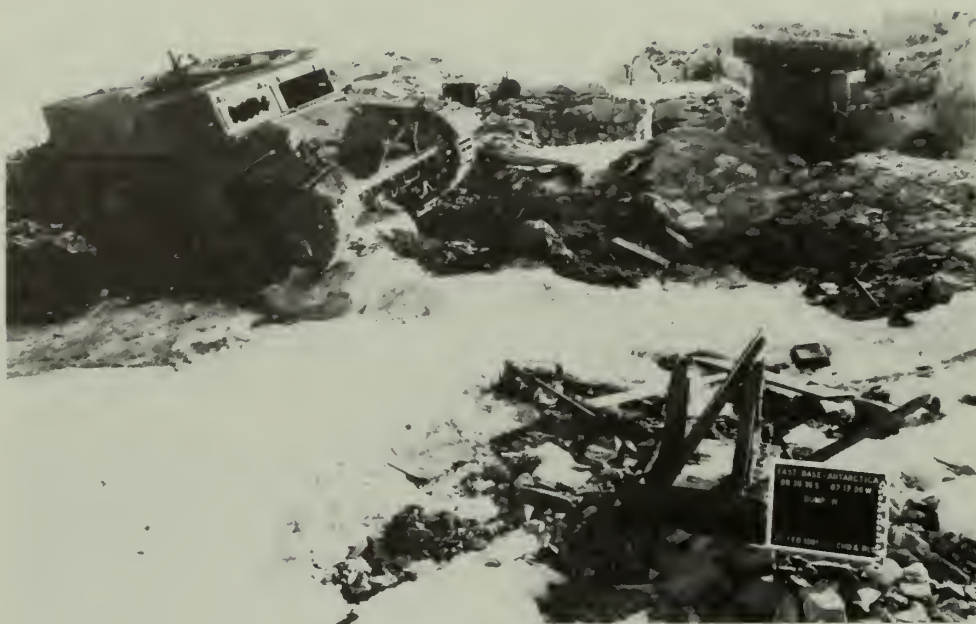
Domestic dumps lie to the east and north of the main group of buildings. While both probably served as kitchen midden areas for the American expeditions, the majority of items appear to be associated with the USAS, 1940-1941. Most of the dump contents were probably deposited by members of RARE when they prepared the base for their own occupation in 1947. Argentine, Chilean, and British activities on the base between 1941 and 1947 may also have contributed to the dumps.

The large extent of each dump makes scientific recovery and subsequent curation almost prohibitively expensive. The presence of medicines and chemicals in the northern dump (dump E) suggests that some hazard may exist to investigators and site visitors if they are careless when rummaging through areas that are inviting "exploration" sites. The dumps are unsightly and contribute to a general atmosphere of neglect at the site.

1. Cover the dumps with a layer of indigenous gravel. This action will remove them from sight, thereby tidying up the site without removing the dumps from their context. It will also hide hazardous materials from curious visitors or animals traversing the surface. Drainage of water through the gravel should not significantly change the abacterial environment.
2. Conduct a systematic sampling of each dump; store material culture on site in a secure area, unless specific repositories are identified in advance of site visit.
3. Allow archeological recovery under permit by legitimate scientists who have identified repositories in advance of site visit.
